Top 10 causes of valve failure

Valves are an inherent and vital part of any process plant. From the humble commodity valves used in instrumentation to the most complex control valve. They all serve a purpose, they all cost money, and they all will need to be replaced sometime in the future.

Unfortunately, as we all know, unexpected failure can be a major cause for replacement. In this article we will be exploring the top 10 causes of valve failure and some mitigation strategies.

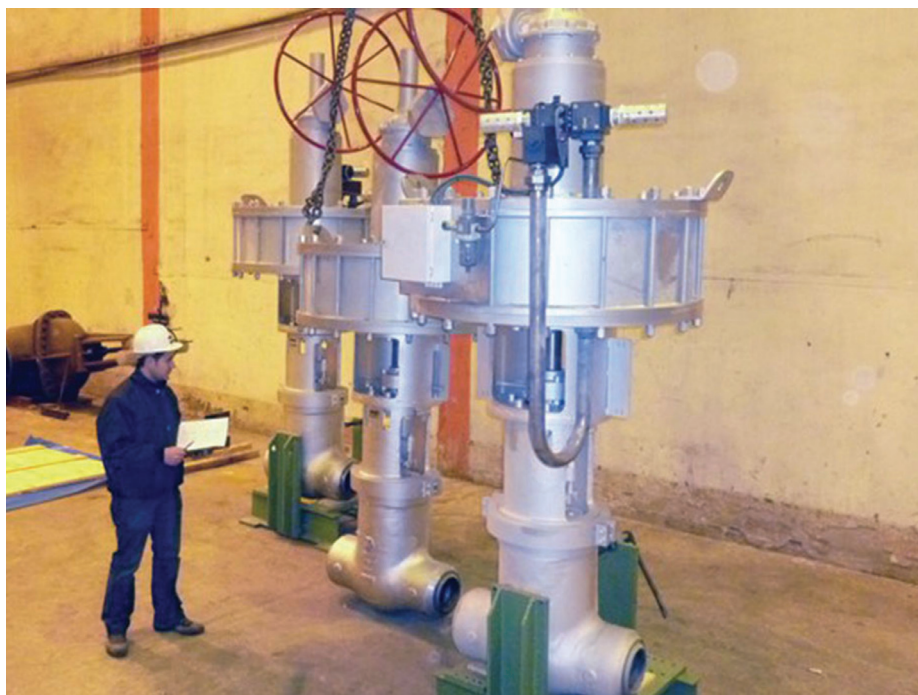
Figure 2 – Valves with large actuators may need additional bracing. Image courtesy of Babcock Valves.

Special care should also be taken with actuated valves with large actuators, such as the one shown in Figure 2. They may require special brackets or additional bracing in order to avoid fatigue failure due to piping vibration, especially in vertical or tilted installation.

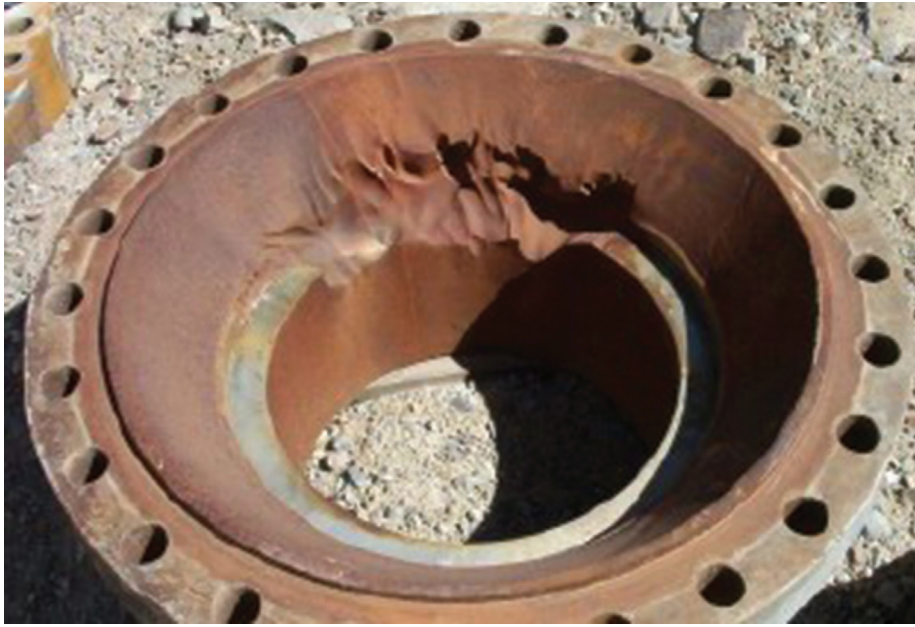
Figure 3 - Damage most likely provoked by erosion in a ball valve used for throttling. Image courtesy of Copeland Ball Valves.

Figure 3 shows an example of erosion damage in a valve body that was most likely produced by leaving the valve half-way between the open and closed position. Given enough time, the erosion may even “dig” through the body and cause external leakage.

If a valve was well handled during all the previous steps and fails during operation, it is almost certain that it was being used in a way not originally planned or in a way that is not suitable for the valve model. A classic example is the use of block valves, such as a ball valve, as a throttling valve. ►
